**SITE LOCATION:** 623 Highland Street**AGENDA ITEM: II.q****HISTORIC DISTRICT:** Woodland Heights**HPO File No. 140218****Owner:** Lisa Sparkes**Applicant:** Bob Birner, Renewal By Anderson**Date Application Accepted:** 1/29/2014**90-day Waiver:** N/A**SITE INFORMATION:**

**TYPE OF APPROVAL REQUESTED: Alteration – Replace 17 original 1-over-1 wood sash windows with 17 1-over-1 composite material sash windows.**

## CERTIFICATE OF APPROPRIATENESS

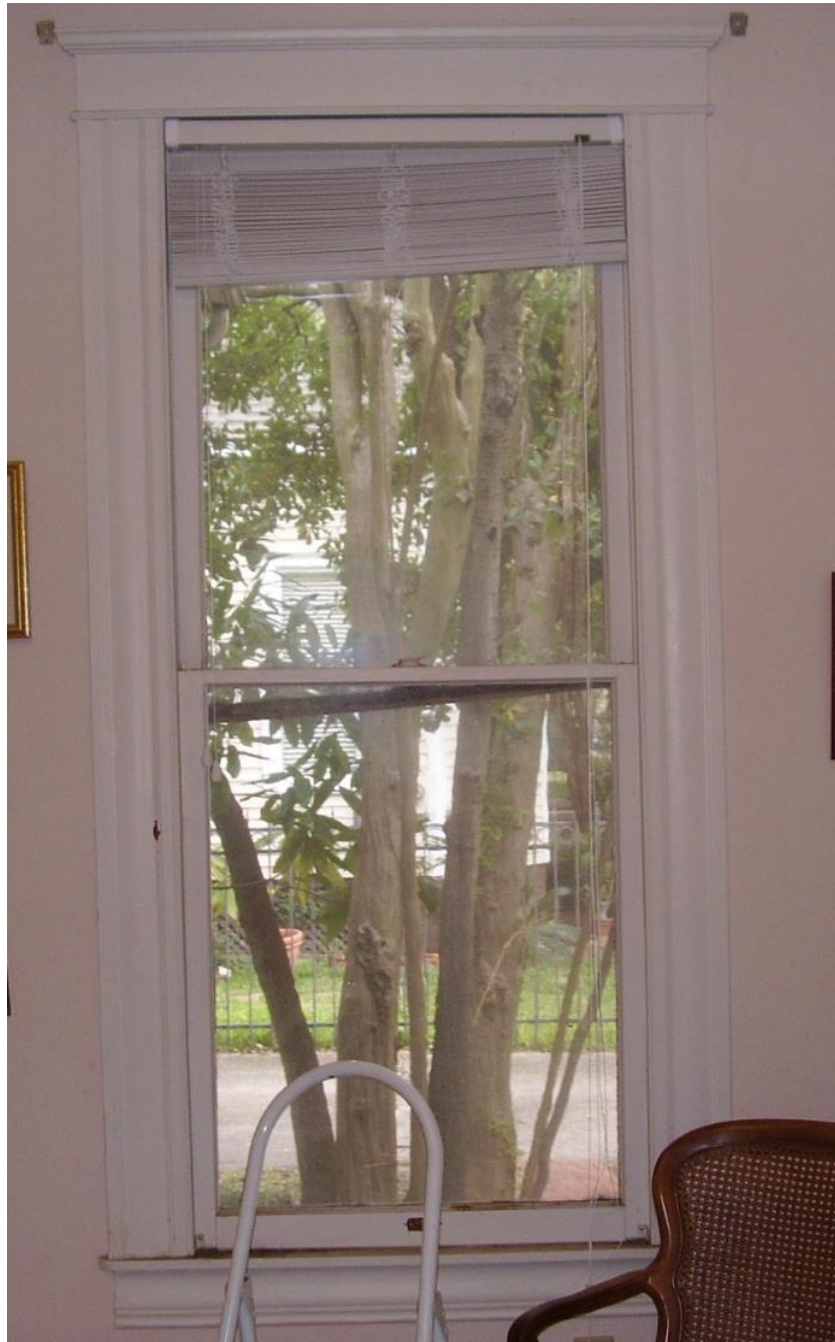
**Window 101**

Window 222 show signs of rot on the bottom sash. Windows 101 and 117 have bowing meeting rails.

Unit #101 Living Room – Sashes are rotted. Damaged beyond repair.

***The existing original 17 sash windows were inspected by the Senior Structural Inspector. The windows have some deferred maintenance but are repairable and are not damaged or deteriorated to the point that warrants their replacement.***

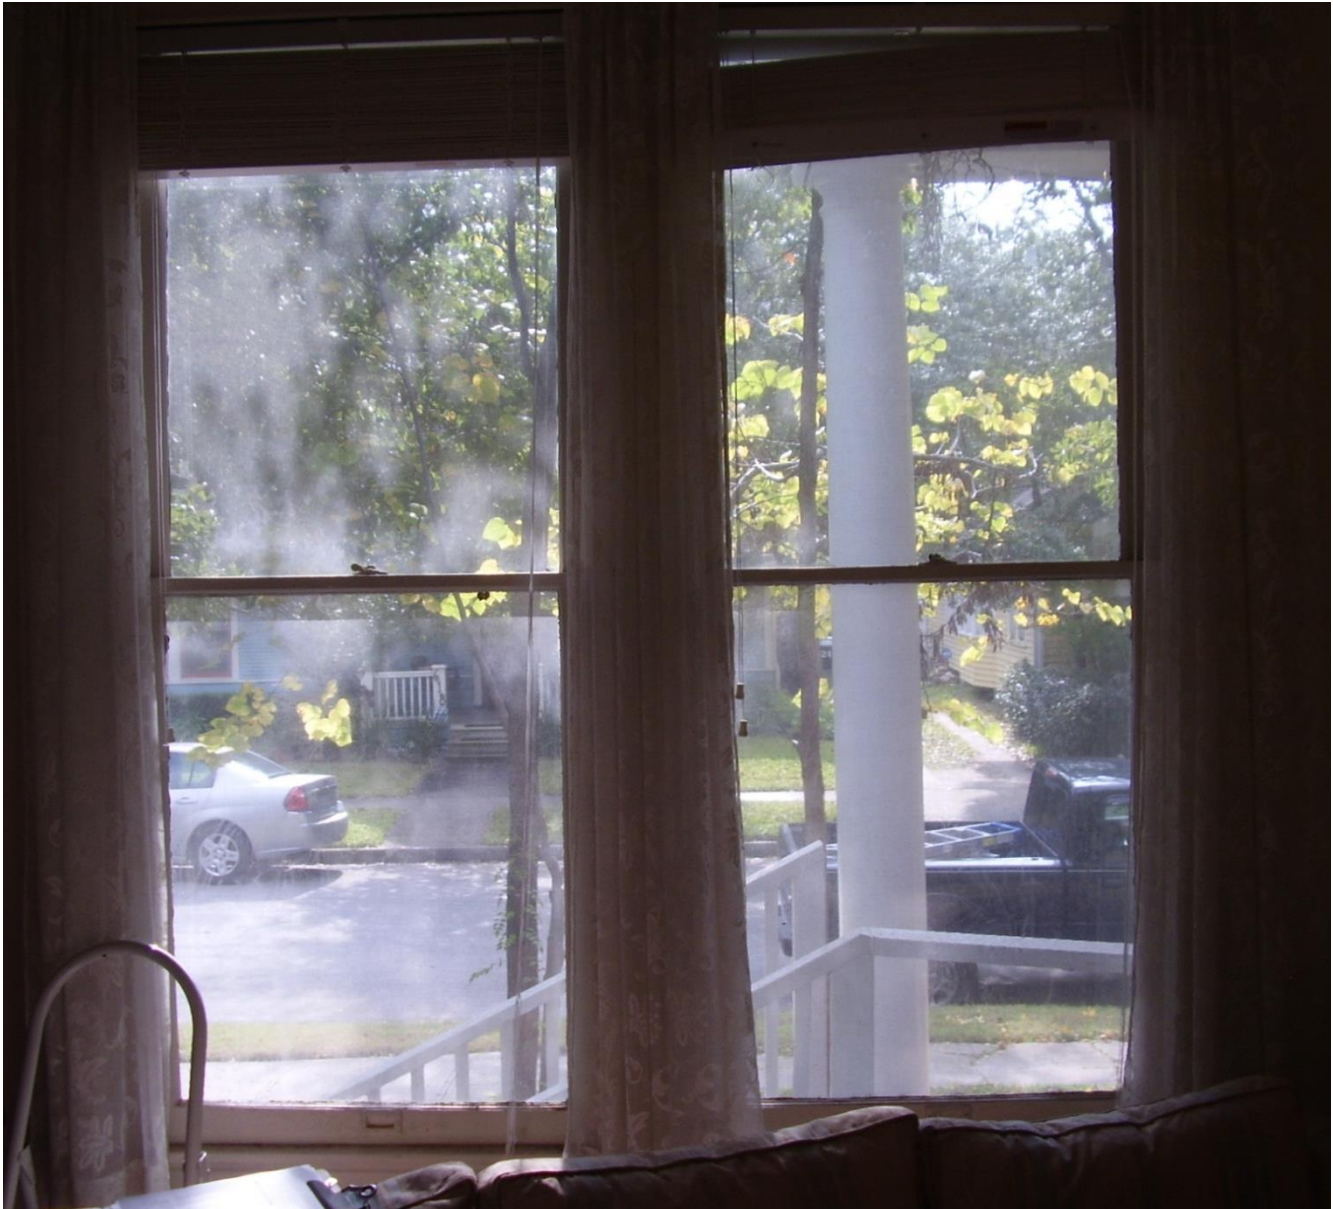
**Windows 102 & 103**

Unit #102 Living Room – Sashes are rotted. Damaged beyond repair.

Unit #103 Living Room - Sashes are rotted. Damaged beyond repair.

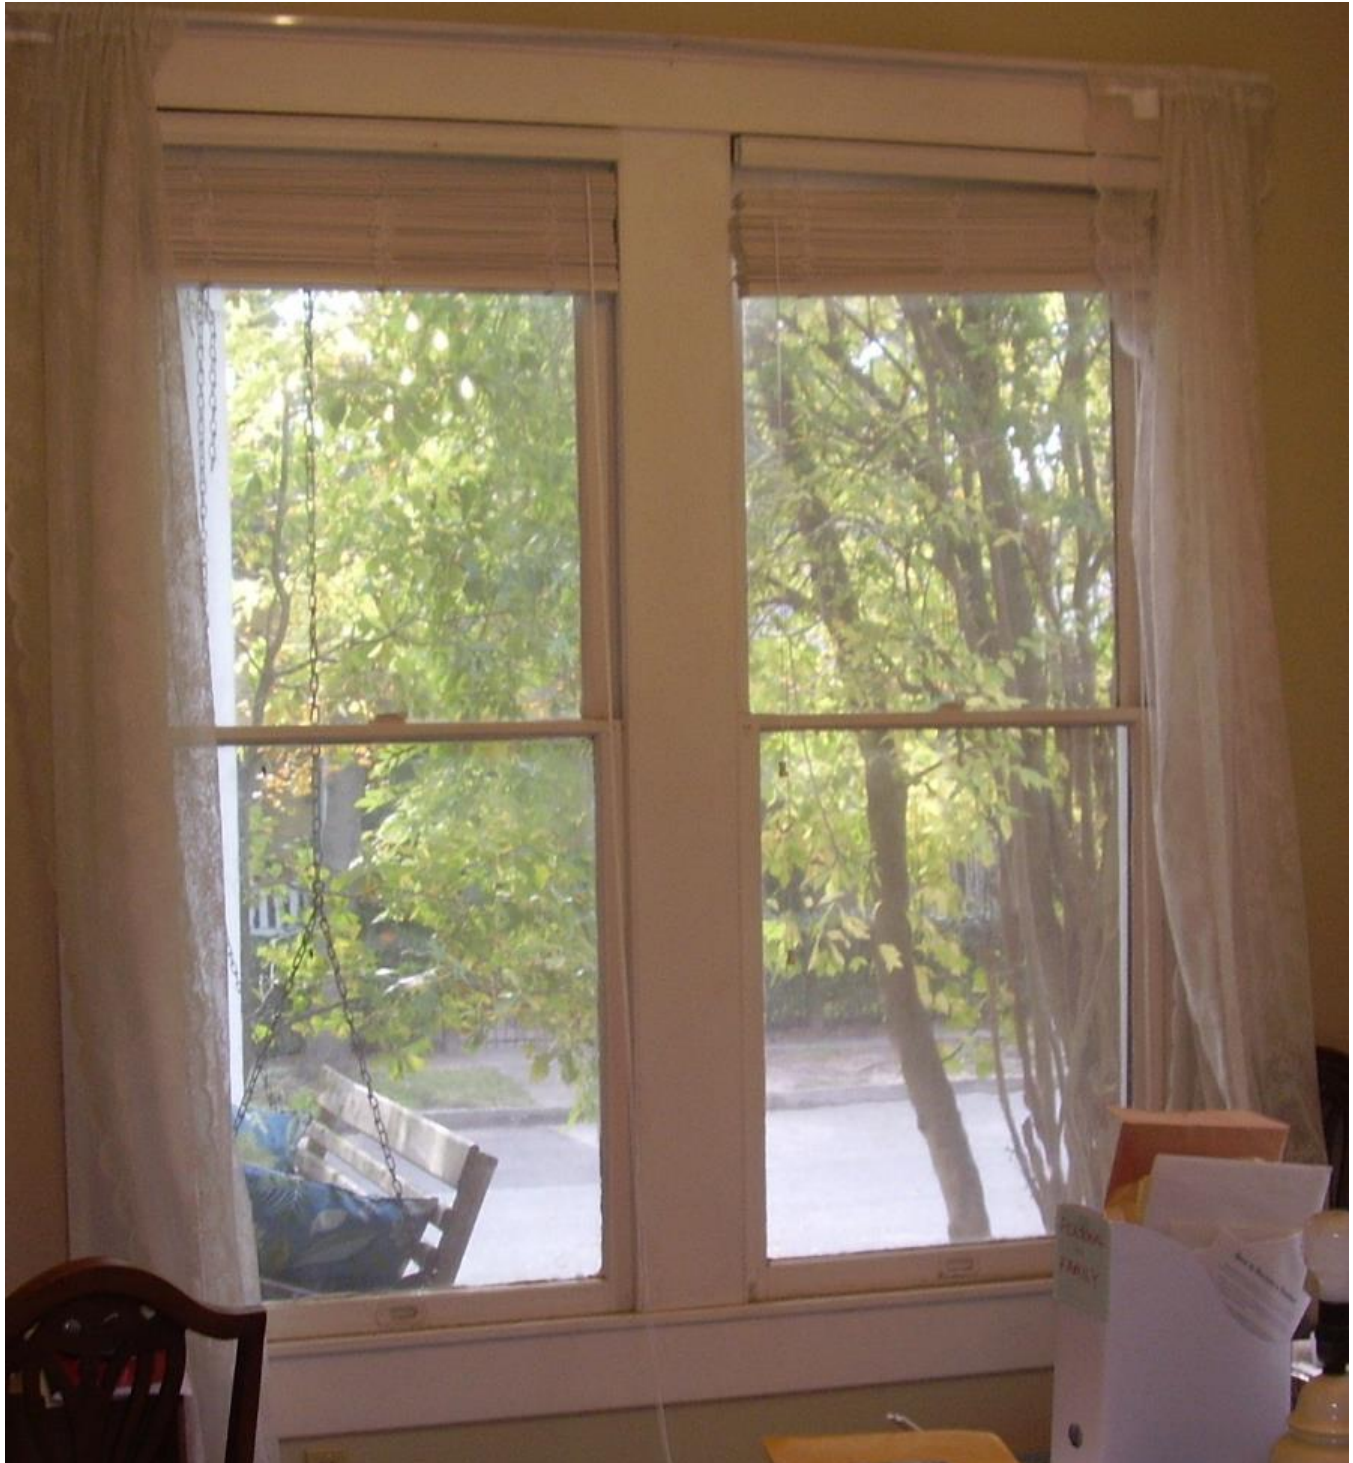
**Windows 104 & 105**

Unit # 104 Living Room - Sashes are rotted. Damaged beyond repair

Unit # 105 Living Room - Sashes are rotted. Damaged beyond repair

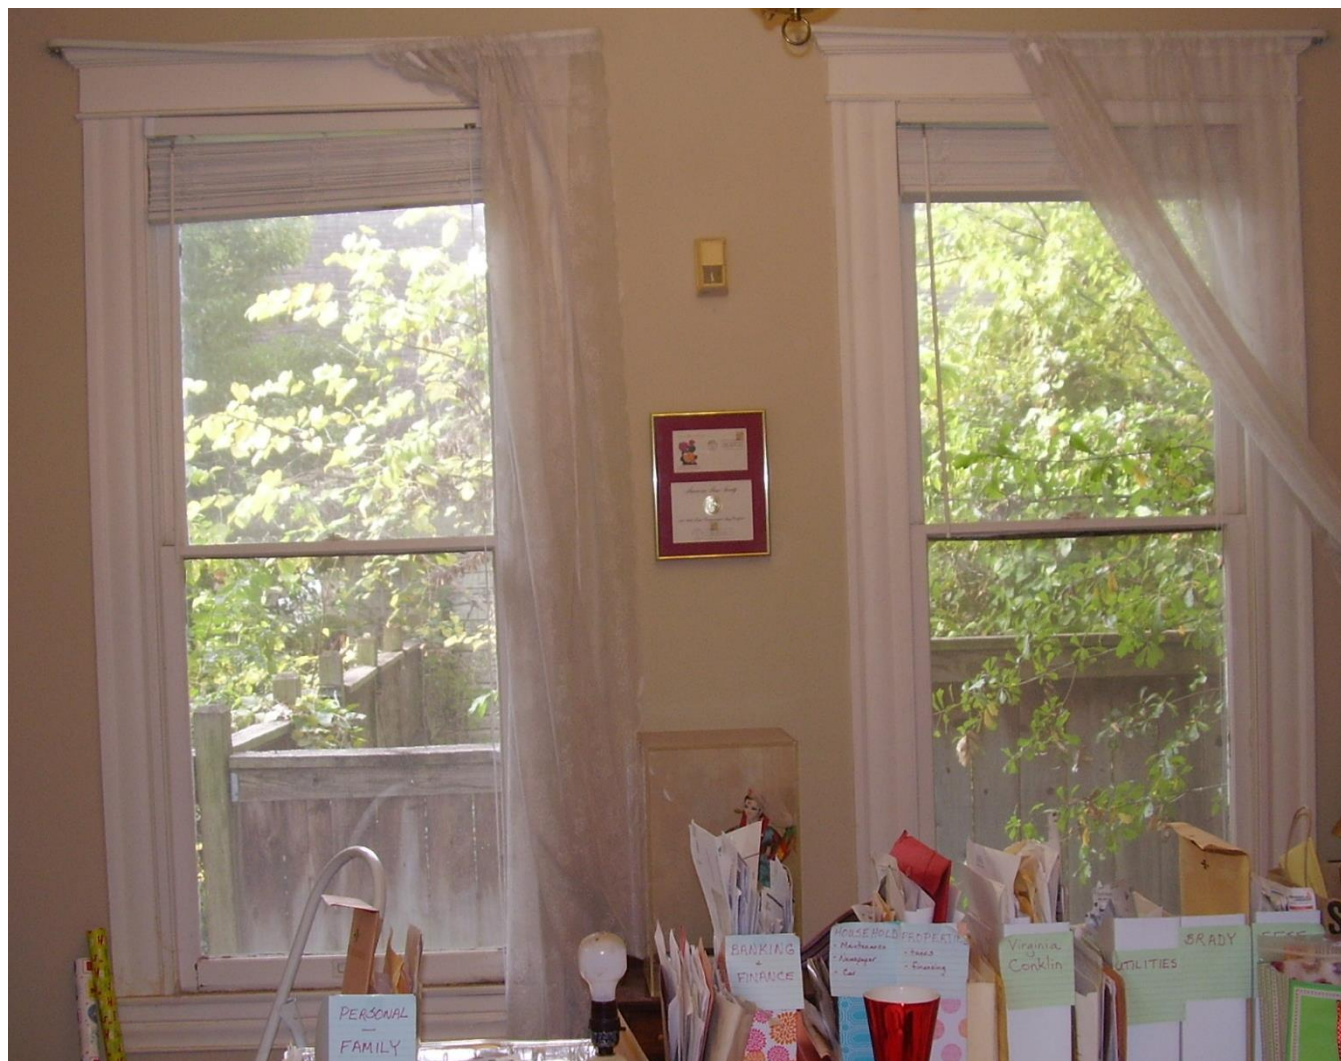
**Windows 107 & 106**

Unit # 106 Dining Room- Sashes are rotted. Damaged beyond repair

Unit # 107 Dining Room - Sashes are rotted. Damaged beyond repair

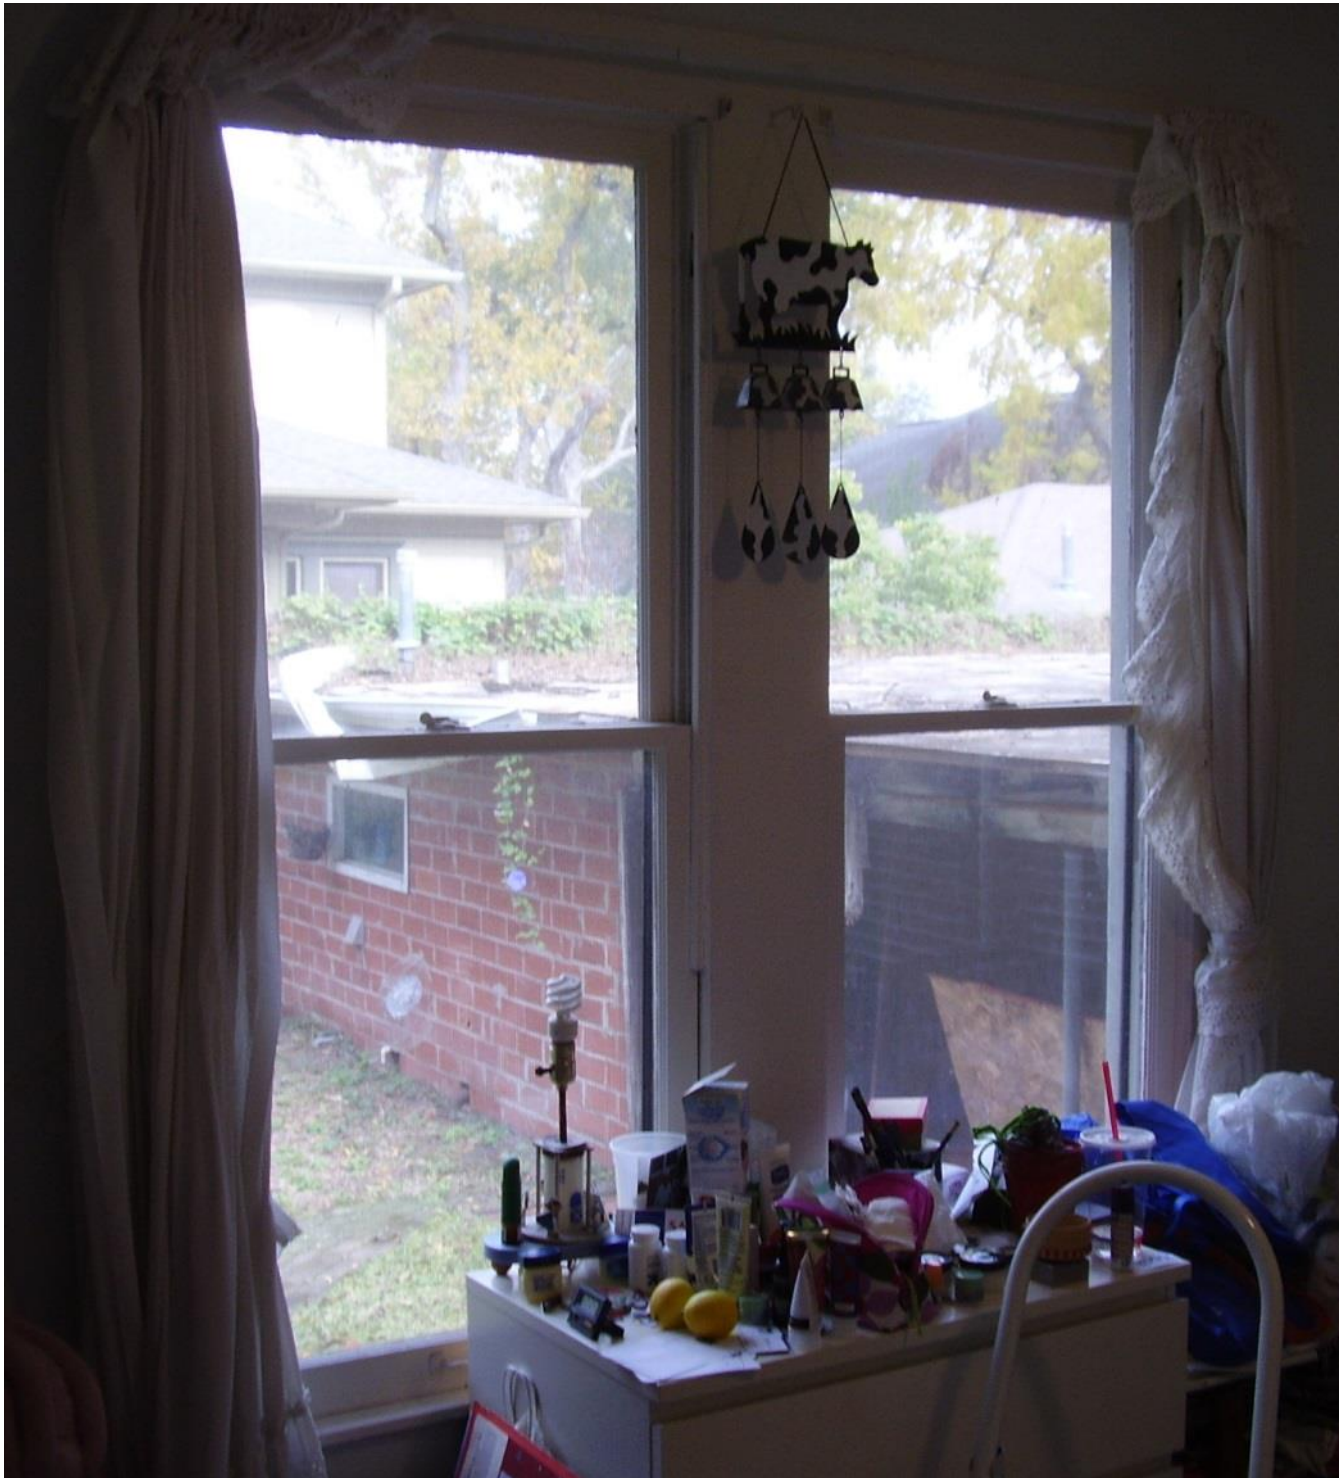
**Windows 112 & 113**

Unit # 112 Bedroom 1 - Sashes are rotted. Damaged beyond repair

Unit # 113 Bedroom 1 - Sashes are rotted. Damaged beyond repair

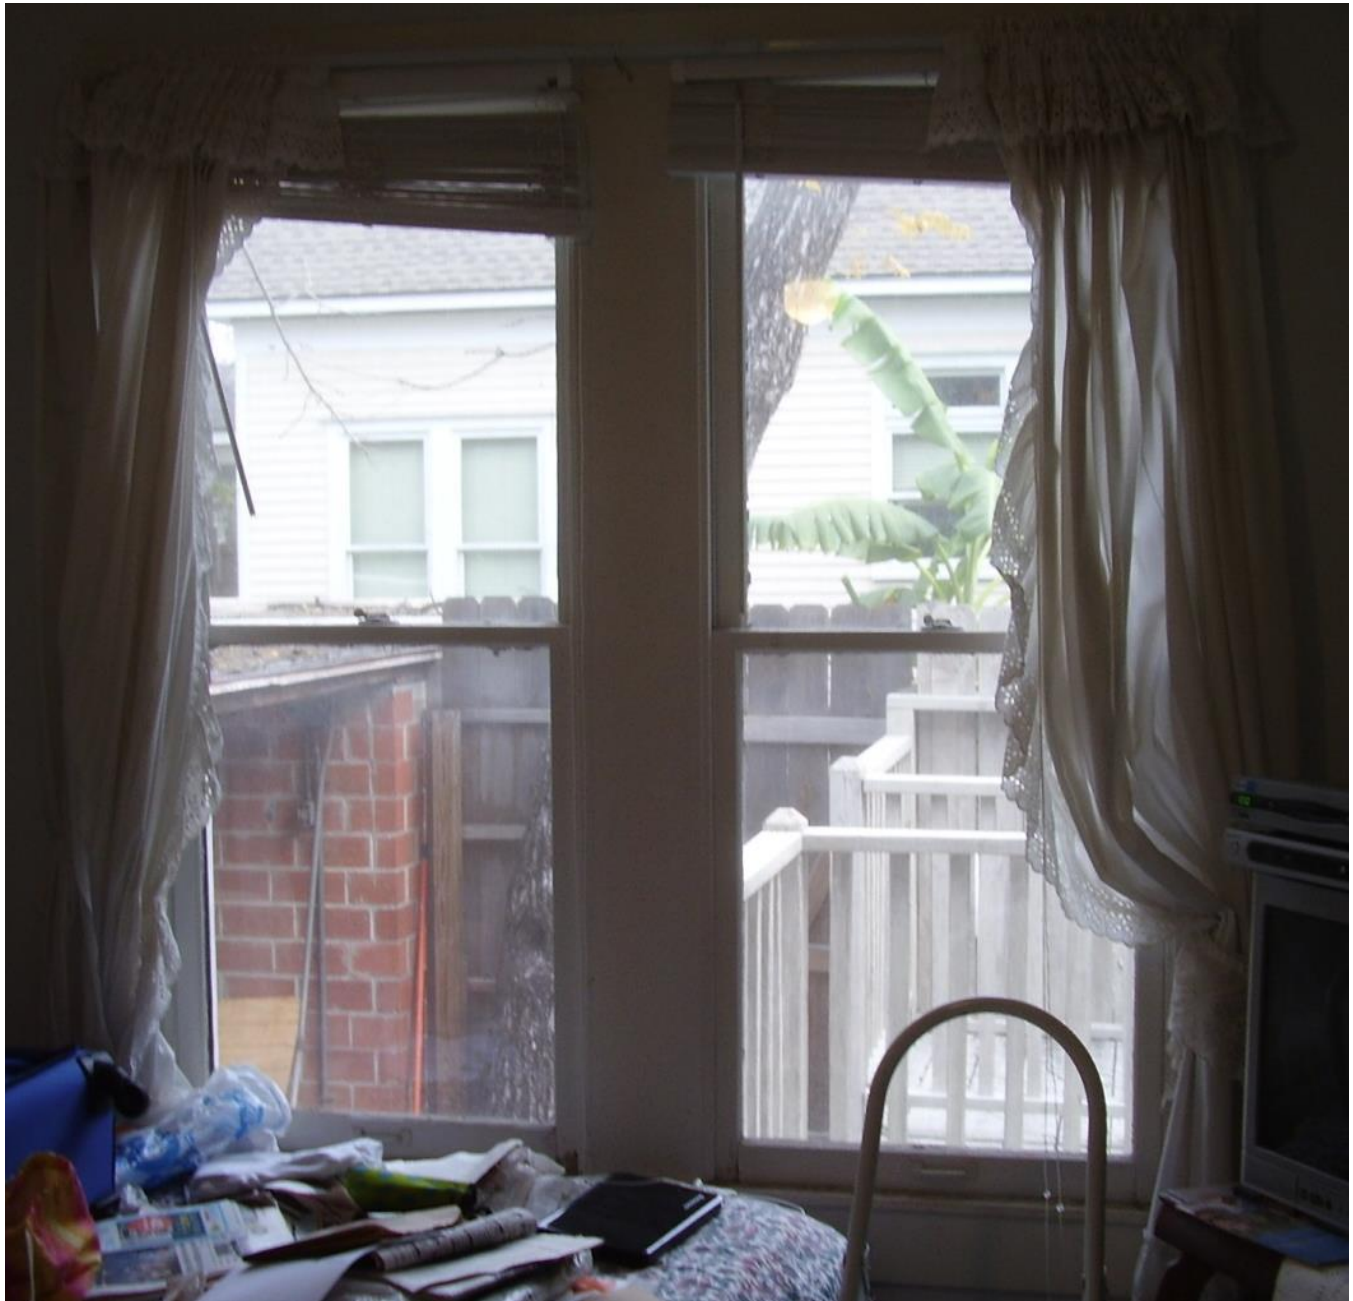
**Windows 114 & 115**

Unit # 114 Bedroom 1 – Sashes are rotted. Damaged Beyond Repair

Unit # 115 Bedroom 1 - Sashes are rotted. Damaged beyond repair

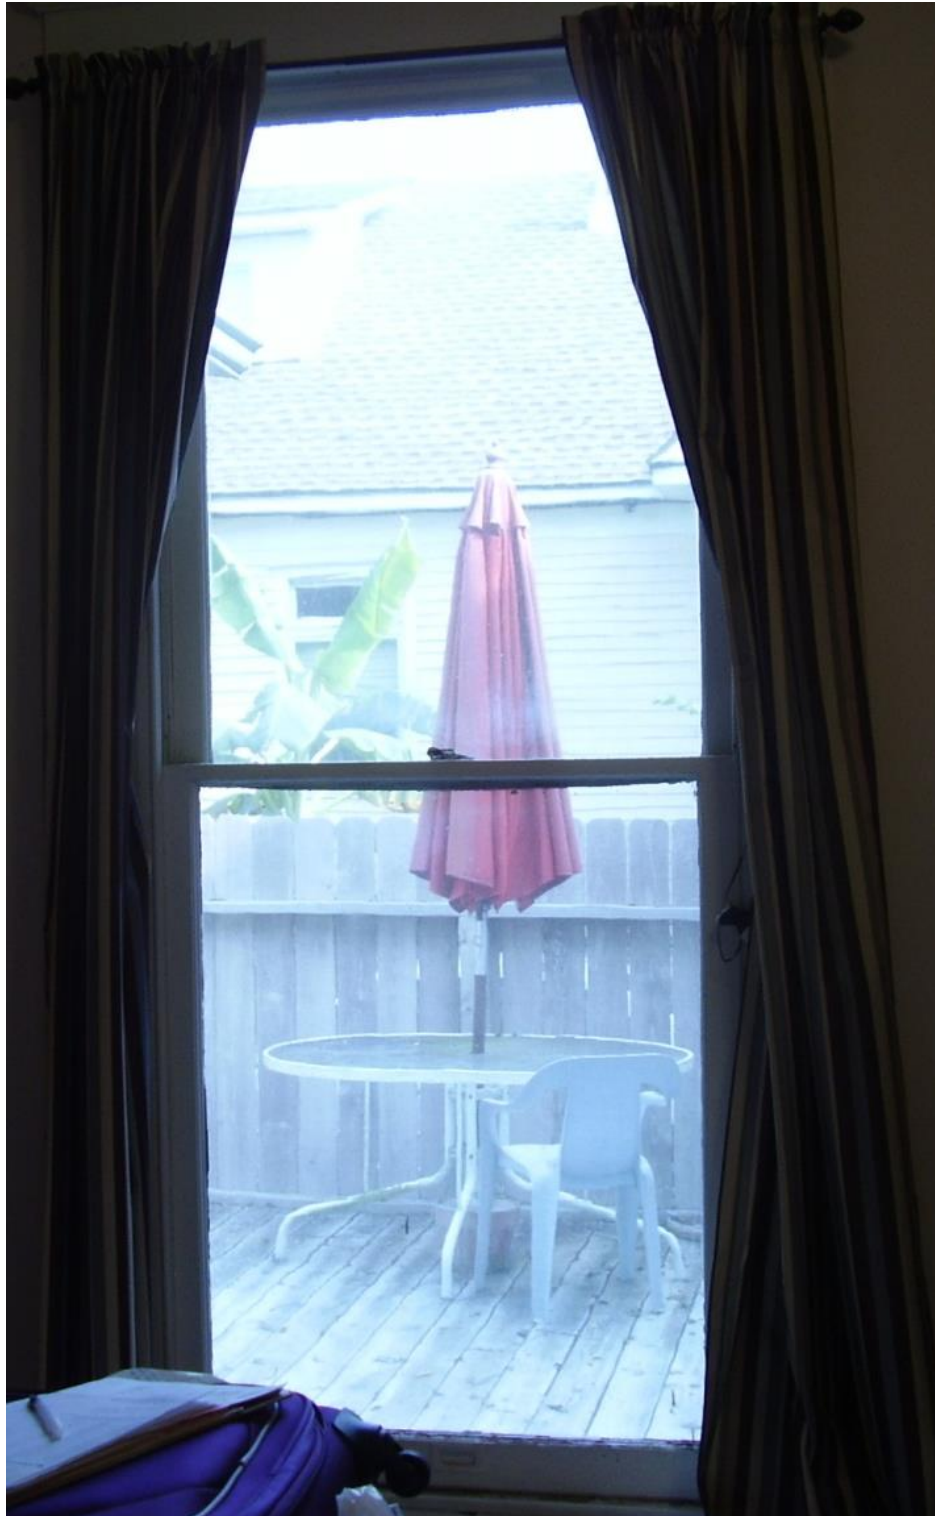
**Window 117**

Unit # 117 Bedroom 2 - Sashes are rotted. Damaged beyond repair

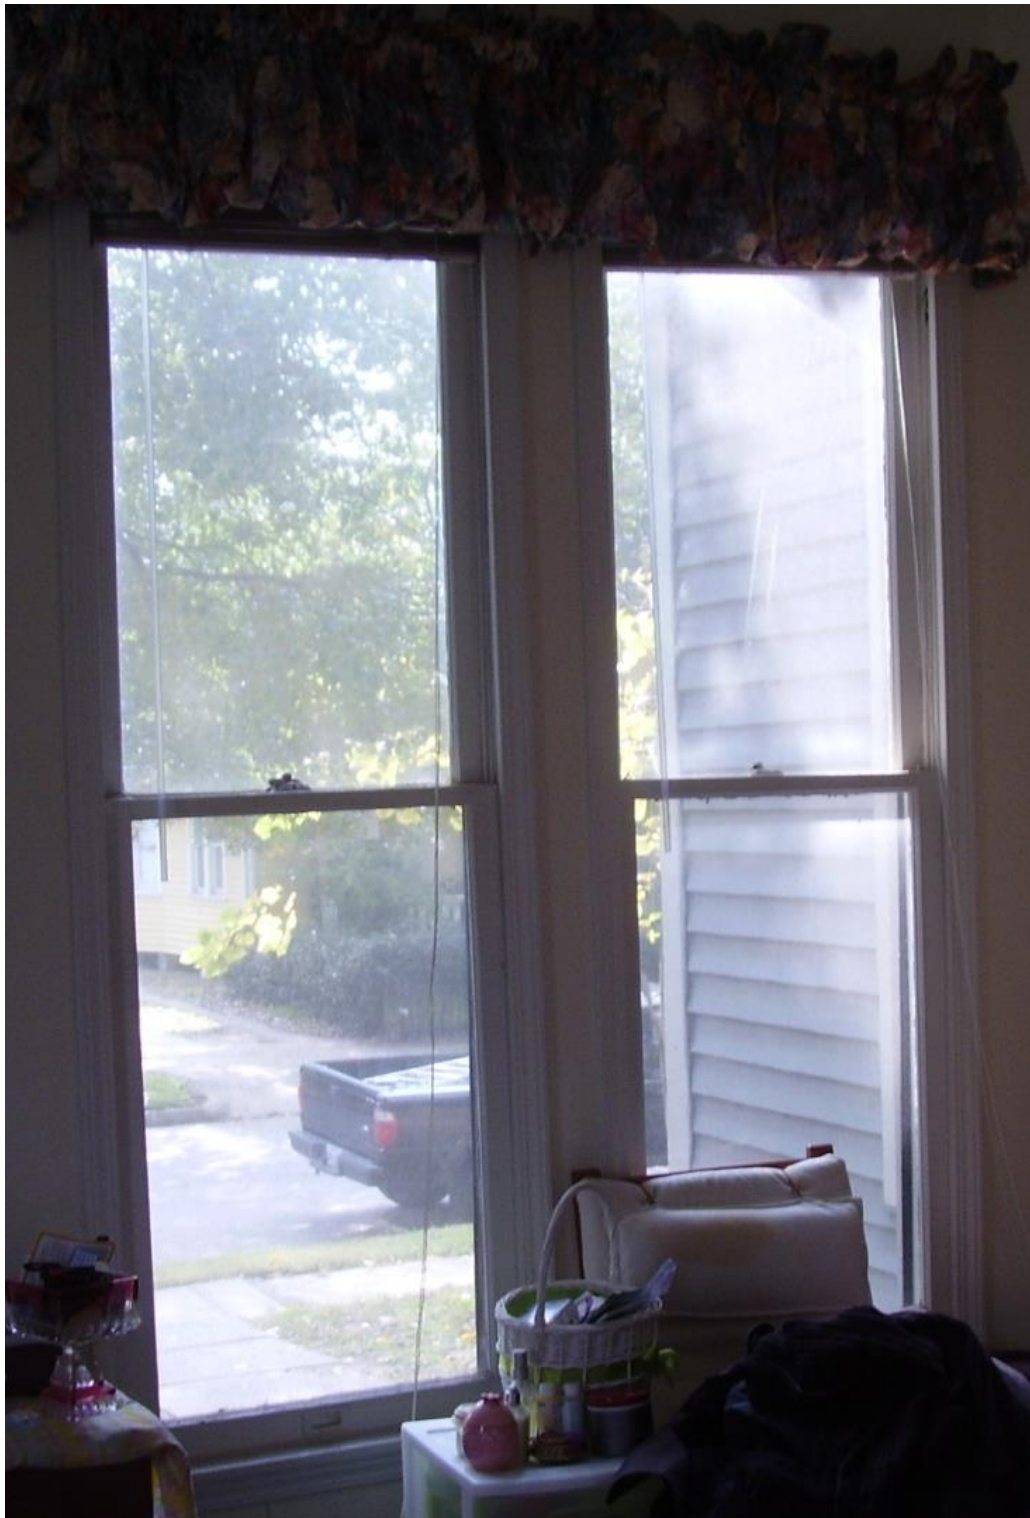
**Windows 118 & 119**

Unit # 118 Bedroom 3 - Sashes are rotted. Damaged beyond repair

Unit # 119 Bedroom 3 - Sashes are rotted. Damaged beyond repair

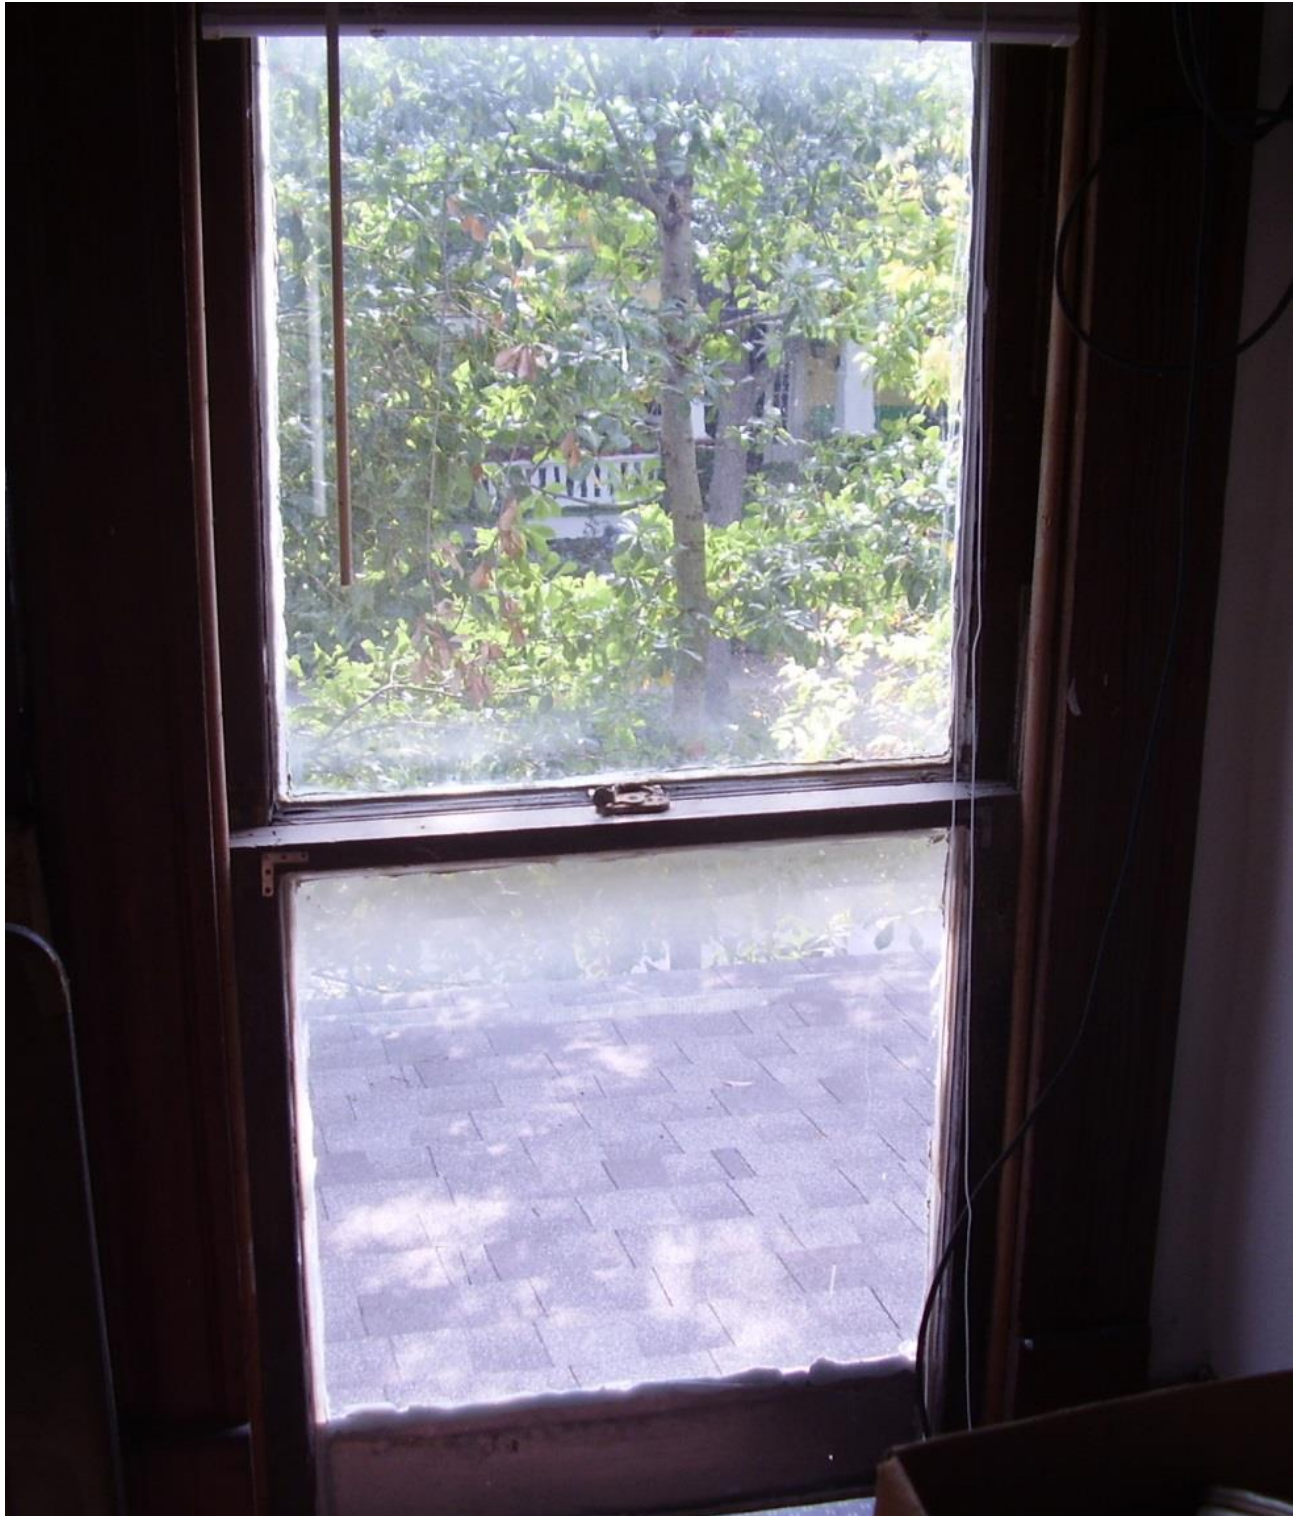
**Window 222**

Unit # 222 Attic - Sashes is rotted. Damaged beyond repair

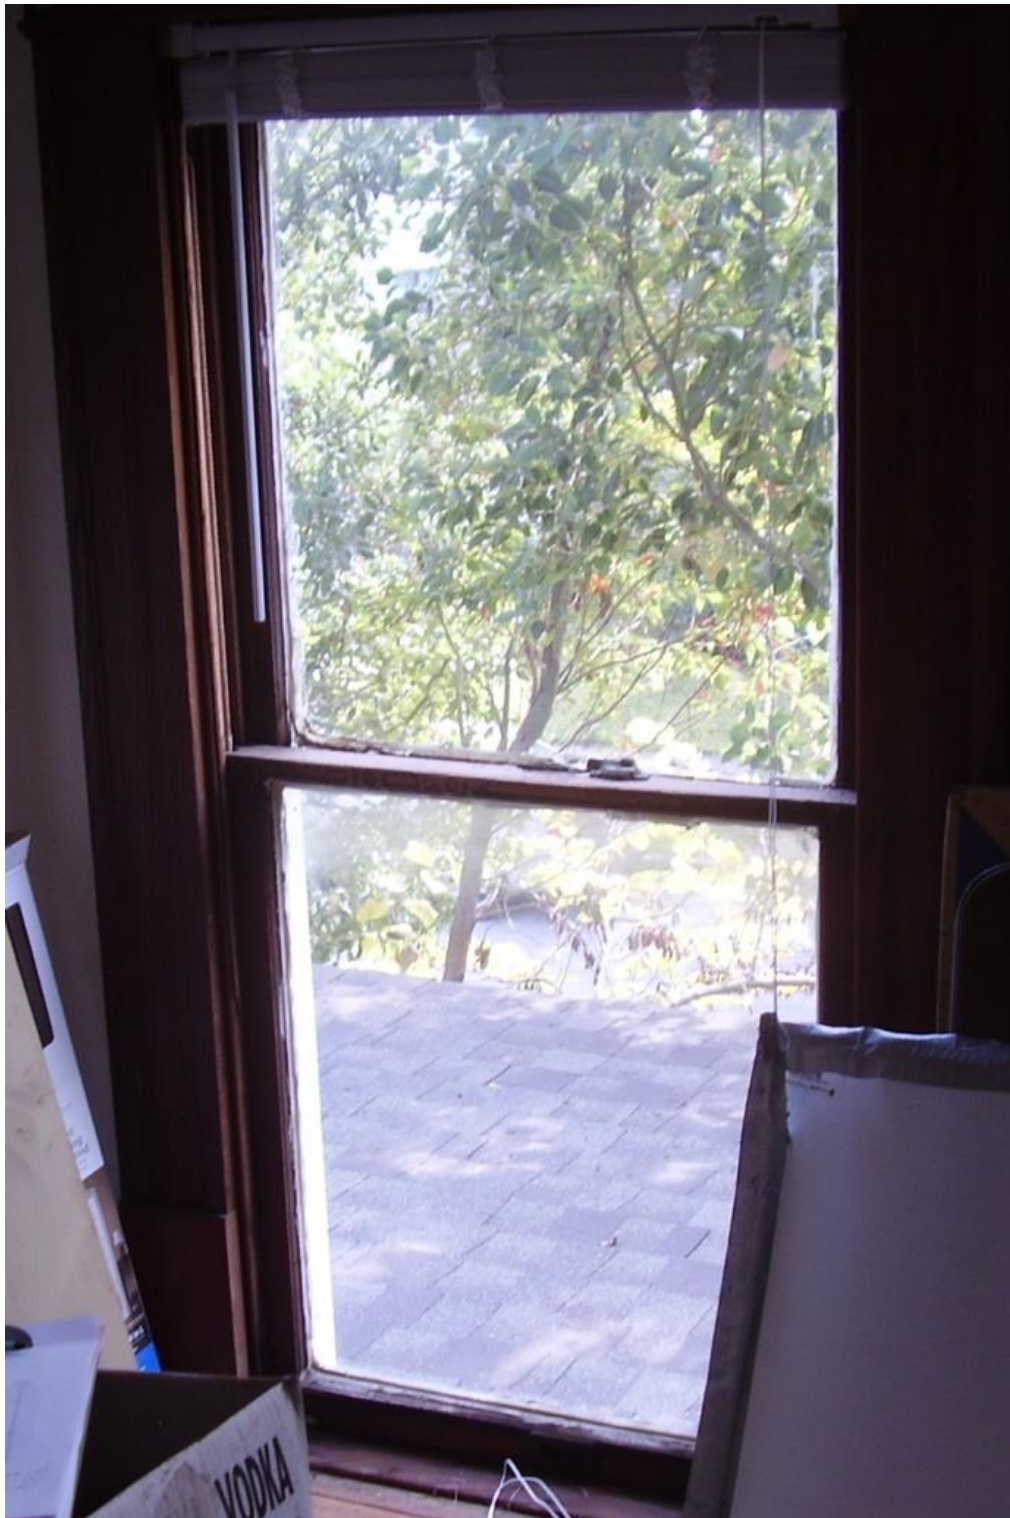
**Window 223**

Units # 223 Attic - Sashes are rotted. Damaged beyond repair
